Microscale resolution fracture toughness profiling at the zirconia-porcelain interface in dental prostheses

Alexander J. G. Lunt^{*a}, Gaurav Mohanty^b, Tee K. Neo^c, Johann Michler^b & Alexander M. Korsunsky^a

ABSTRACT

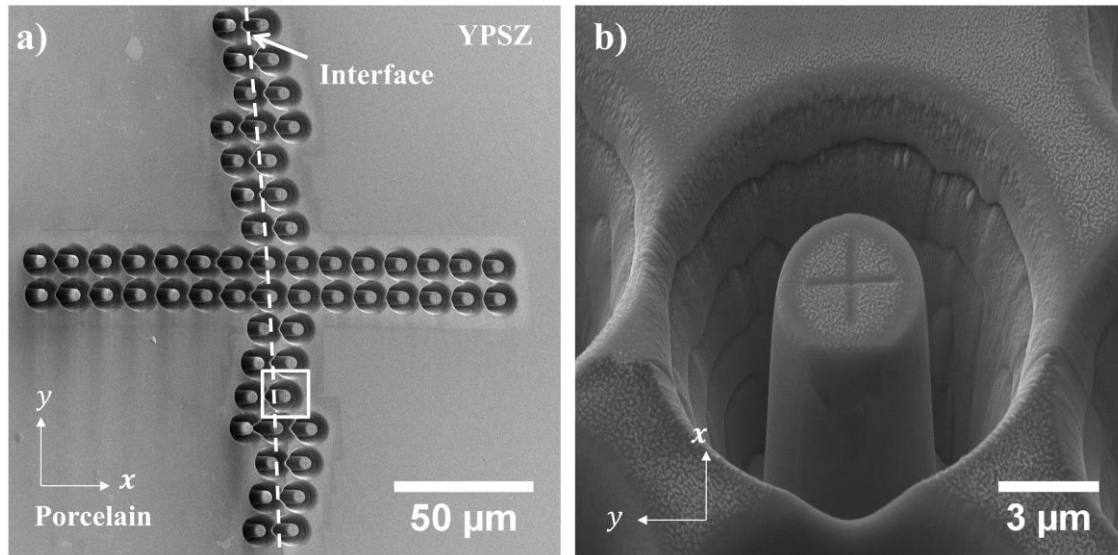
Figure 1. a) Positions of FIB milled micropillars across the YPSZ-Porcelain interface. The number of pillars near to the interface has been chosen to be large in order to gain improved insight into the statistics of this region. b) A high magnification of one of the pillars (the location of which is shown in Figure 1a showing the indentation alignment cross on the center of the pillar. Both images were captured at a SEM tilt of 55° using tilt correction in the x direction. Figure 1a has been rotated to be orientationally consistent with the other figures presented in this study.

FIB milling was used to generate an array of micropillars which were aligned in a direction perpendicular to the interface as shown in Figure 1a. This pattern was selected to maximize the number of pillars within the first 15 µm of the interface in order to enable improved statistics to be captured in the location where most variation was expected. FIB milling was performed on the TESCAN Lyra 3 FIB-SEM at the Multi-Beam Laboratory for Engineering Microscopy (MBLEM),

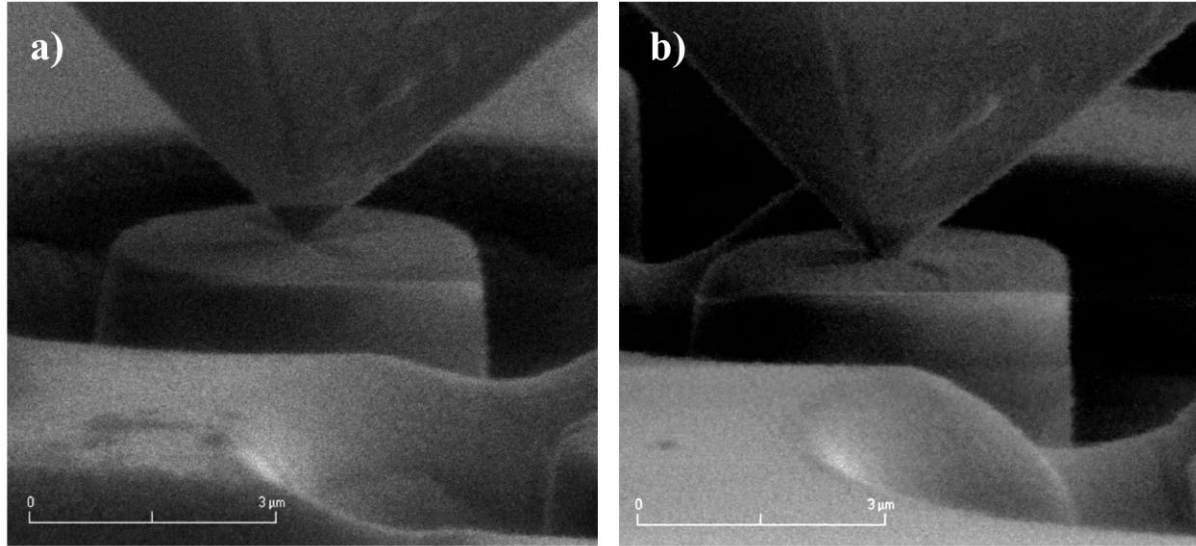
Video 1a and 1b. Videos of cube corner nanoindentation splitting in a) YPSZ (9 μm from interface) and b) porcelain (11 μm from interface). The more ductile fracture mode of YPSZ and brittle response of porcelain are demonstrated in these two videos. <http://dx.doi.org/doi.number.goes.here>

As previously highlighted in Section 3.2, distinct differences were observed between the YPSZ, porcelain and interface (containing both YPSZ and porcelain) failure modes. Video 1a and Figure 3 both demonstrate that the failure of YPSZ is gradual and occurs by crack propagation and slow growth under increasing load. This results in a reduction in gradient on the load-displacement curve which is indicative of energy absorption and a ‘plastic’ type failure. The multi-faceted crack

surfaces observed in the fractured pillars (Figure 5c) provide further evidence that YPSZ failure is associated with gradual crack growth. In contrast to this behavior, Video 1b and Figure 3 highlight the brittle failure mode induced in porcelain. There is no change in gradient on the load-displacement curve and complete pillar fracture occurs at a point at which there were no visible cracks in the pillar surface.

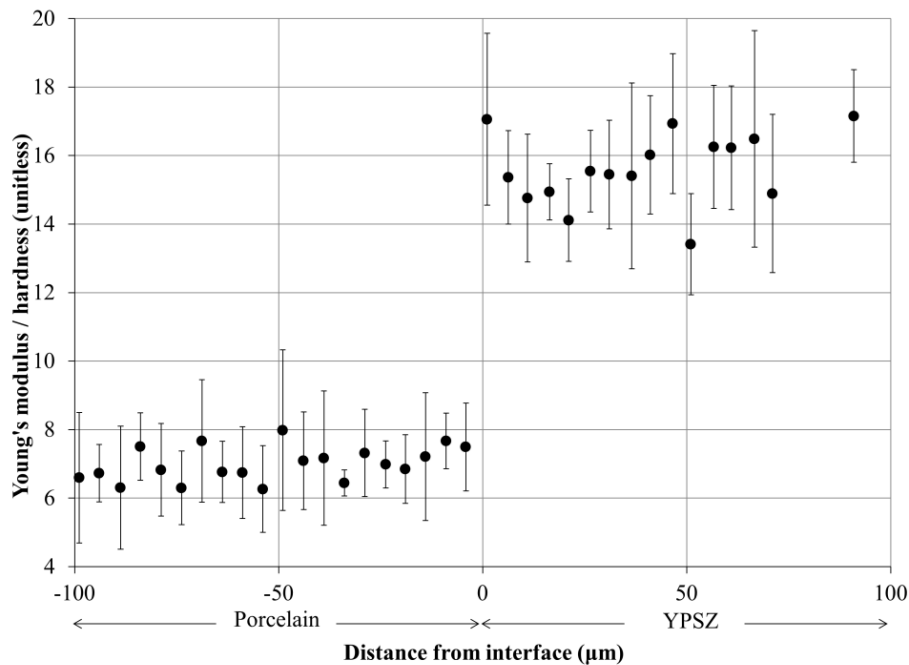
Figure 2. Variation of Young's modulus / hardness as a function of distance from the YPSZ-porcelain interface. The data values obtained for this distribution were taken from micropillar compression study published by Lunt et al. [11] and have made use of the approximation that hardness is approximately equal to 3 times the yield strength. The error bars indicate the 95% confidence intervals of each value.

where x is the distance from the interface. The standard deviations of E and σ_y were used to calculate the 95% confidence intervals of E/H and the results are shown in Figure 2.

Critical examination of Figure 2 reveals that within each material the scatter of E/H is generally equal to or smaller than the 95% confidence intervals of each value. This means that, to within the scatter of the results obtained experimentally, the value of E/H can be considered to be approximately constant in both YPSZ and porcelain. Further, as highlighted in Equation 2, it can be seen that moderate changes in the value of E/H result in very small changes in γ_B , i.e. the fracture toughness estimate is robust to minor deviations in E/H . This approximation of constant material mechanical parameters in both YPSZ and porcelain was therefore used in the remainder of the analysis.

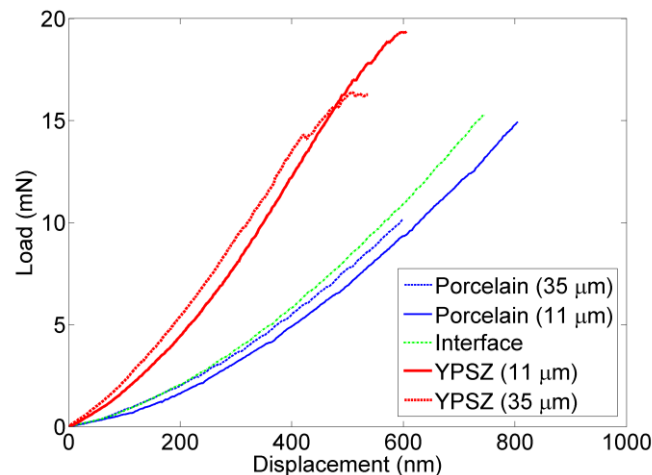
Figure 3. Typical load-displacement plots for YPSZ, porcelain and the interface up to the point of brittle failure. The distance from the interface to the pillar center is given in the plot legend. YPSZ shows plasticity prior to critical failure whereas no reduction in gradient is observed in porcelain or the interface indentation.

After successfully fracturing each of the 60 FIB milled pillars, analysis was performed on the load-displacement curves obtained from the analysis. Distinct differences were observed between the fracture of the YPSZ and porcelain micropillars, examples of which are shown in Figure 3. In the case of porcelain, brittle failure occurred without the onset of plasticity. However in the case of YPSZ, a gradient decrease in the load-displacement plot was observed prior to failure. Despite these differences consistent estimates of the critical instability load (P_C) were obtained from each of the pillars from the point where large drops were observed in the load.

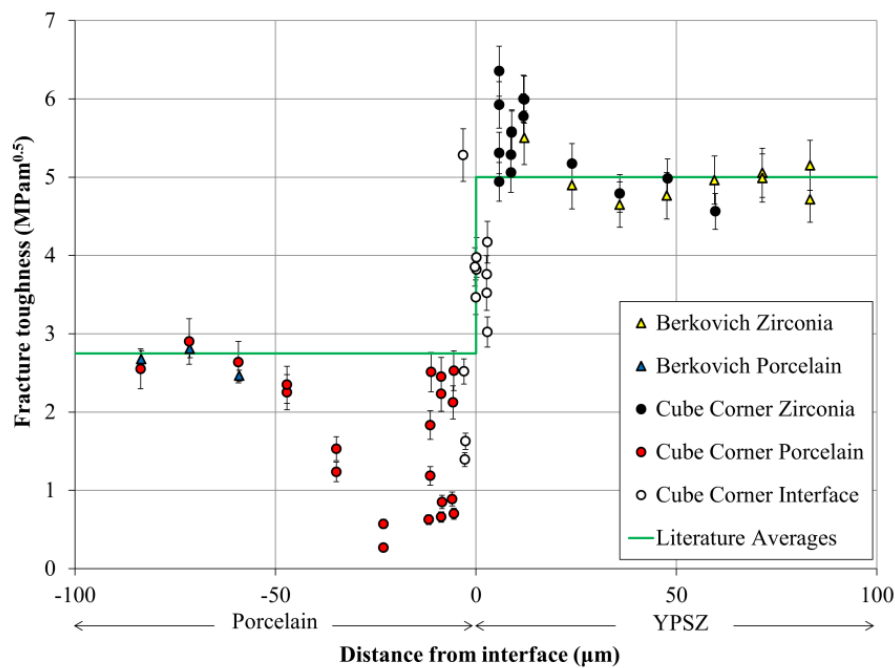
Figure 4. Fracture toughness variation across the YPSZ – porcelain interface showing YPSZ on the right (positive distances) and porcelain on the left (negative distances). The results from both Berkovich and cube corner indentation are shown along with the average values obtained from the literature [28, 33]. At the interface an average of the γ values for the two materials was used to calculate the fracture toughness. The error bars shown indicate the 95% confidence intervals of each measurement.

The magnitude and standard deviation of γ_C for YPSZ and porcelain obtained from this analysis are given in Table 1. These estimates were then used in combination with the critical fracture toughness values to obtain estimates of the K_C in the YPSZ and porcelain near-interface regions. At the locations where both YPSZ and porcelain were contained within the pillar an average value of $\gamma_C = 0.5 \times (\gamma_C^{\text{Zir}} + \gamma_C^{\text{Por}})$ was used to determine K_C . The standard deviations of the fracture toughness values were obtained from the combined uncertainties of each of the parameters used in their calculation and the results of this analysis are shown in Figure 4.

Examination of the fracture toughness variation across the interface in Figure 4 reveals that beyond 50 μm from the interface in porcelain and beyond 25 μm in YPSZ, the fracture toughness is approximately constant and equal to the average values published in the literature [28, 33]. This suggests that the results obtained through the use of Berkovich pillar splitting approach developed by Sebastiani et al [23, 27] are reliable in both YPSZ and porcelain. Further, the minimal variation in fracture toughness ensures that the calibration of γ_C implemented based on constant K values outlined in Section 3.2 is valid.

Clear differences can be observed between the literature average values of fracture toughness and those obtained micropillar splitting for both YPSZ and porcelain in the near-interface region (Figure 4). A clear reduction in fracture toughness (by up to ~90%) is observed in porcelain starting at a distance of approximately 50 μm from the interface and extending to the near interface location. This variation is highly self-consistent in the pillars between 50 and 15 μm from the interface, suggesting that this weakness may be associated with a gradual variation in mechanical properties. For example, elemental diffusion or long-range grain refinement effects, both of which are known to influence the fracture toughness behavior of porcelain [35]. In contrast to this behavior, at distances less than 15 μm from the interface, a large amount of scatter is observed within the data suggesting more statistically driven weaknesses than those observed at larger distances. The fracture toughness estimates within this range vary from 0.6 – 2.5 $\text{MPam}^{0.5}$ which demonstrates that the bulk mechanical behavior is present within some near-interface positions.

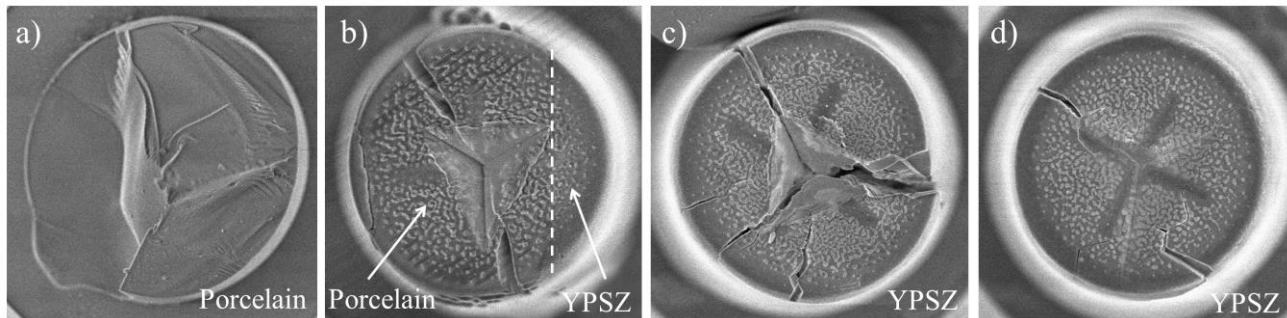
Figure 5. SEM images of fractured pillars. a) Complete brittle failure of the porcelain micropillar located 47 μm from the interface. The remaining stub base is shown, along with the smooth fracture surfaces. b) Typical near-interface cube corner micropillar failure showing the pillar splitting into two halves. Examination of multiple interface fractures revealed that the fracture direction was often closely aligned to the interface. c) Typical YPSZ cube corner tip fracture showing multiple cracks from the center to the edge of a pillar located 11 μm from the interface. d) Berkovich tip indentation of the YPSZ micropillar located at 35 μm from the interface. Two cracks can be observed from the edge of the pillar running towards the center.

Examination of the SEM images of the fractured pillars revealed that the average offset between the center of the pillar and the indenter tip was less than 100 nm for the cube corner indentations, compared with 100 – 300 nm for the Berkovich tip. Four main failure modes were observed in the pillars depending upon the substrate material, location and indenter tip geometry as shown in Figure 5. Examination of the porcelain micropillars revealed that for many of the tested positions, the indentation had been sufficient to fully fracture the stub, leaving only the base or a small section of the pillar (Figure 5a). The smooth, sharp facets observed on the remaining surfaces suggested that porcelain failure was brittle, in contrast to the gradual failure observed in YPSZ. In near-interface pillars, which contained both YPSZ and porcelain within a single pillar (Figure 5b), a different failure mode was widely observed. Typically the pillar was found to fracture into two pieces, with the direction of fracture being closely aligned to the interface direction. The fracture observed in these pillars was sharp suggesting a single failure event, and the crack was typically induced within the porcelain at a distance

of between 1 – 2 μm from the interface. Cube corner indentation of YPSZ resulted in pillar splitting along the sharp edges of the indent as shown in Figure 5c. The surface of these fractures was highly faceted suggesting failure did not propagate fully during a single fracture event, but increased gradually through the continued application of load. In contrast to this behavior, Berkovich indentation cracks were localized to pillar edges in YPSZ, this was believed to be associated sub-surface cracking which propagated to the pillar surface as shown in Figure 5d.
